# Case Study Isolating Centrifugal Pumps on Fully Decoupled Inertia Slabs

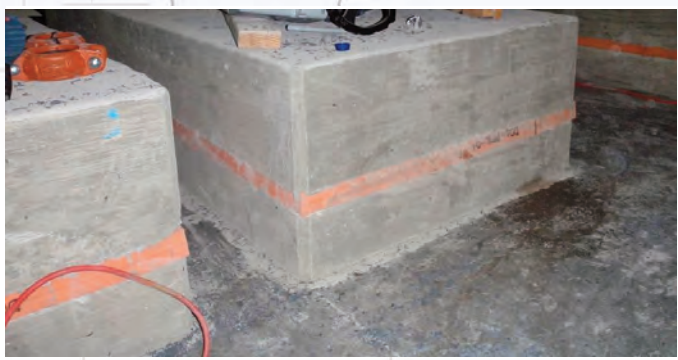
The greatest problem in the case of the aquarium project was due to the great number of different pumps with different performance requirements requiring the selection of a solution with most accurate definition of gage and load deflection to assure the strict alignment of all the pre-designed plumbing components.

Based on the given target frequency for each pump, calculations were done individually with the Getzner's FreqCalc online calculation tool. The minimum required frequency ratio of 1.6 (excitation to disturbing frequency) given by the responsible acoustic consultant Wilson, Ihrig & Associates could be reached with a material thickness as low as one inch. Even lower ratios would have been possible, but the cost factor and the customer's desire to pour the concrete in place without any additional distribution layers made a full surface bearing the best solution.
